Commissioning Report Saturday 22nd August 2009

Customer: xxxxxx Ltd

Date of Visit 22nd August 2009

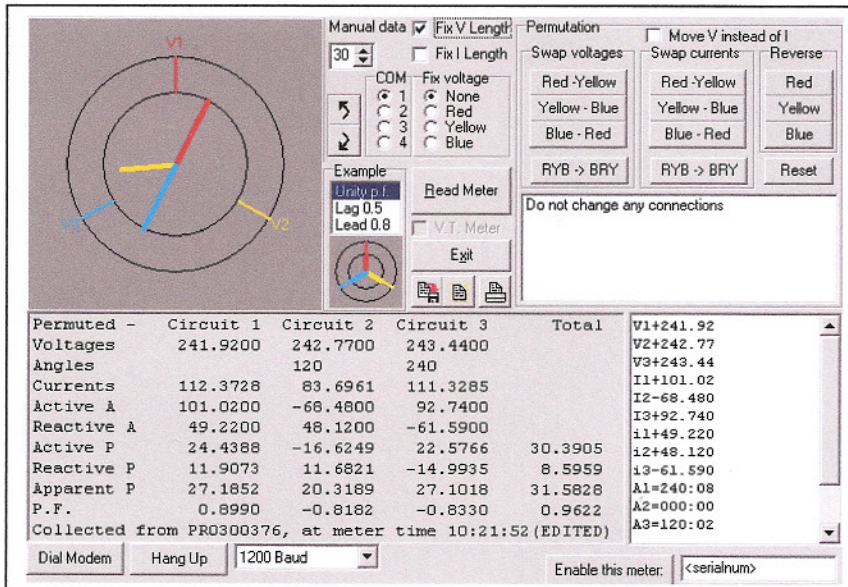
The Premier sub-meter has diagnostic capabilities and by connecting to the meter with a laptop it was possible to check the operation of the meter. The screen shot below shows that there was something wrong with the operation of the meter.

The Premier measures voltage and current independently on each of the three phases and the relationship between voltage and current. It is clear from the image below that one of the phases appears to be running backwards.

I1 = 101.02A, I2=-68.480A & I3=92.740

Active power from which kWh consumption is derived from the image below is:

$$kW = 24.4 - 16.6 + 22.5 = 30.3kW$$

Active power should have been

$$kW = 24.4 + 16.6 + 22.5 = 63.5kW$$

In effect the meter was recording only approximately half the actual consumption.

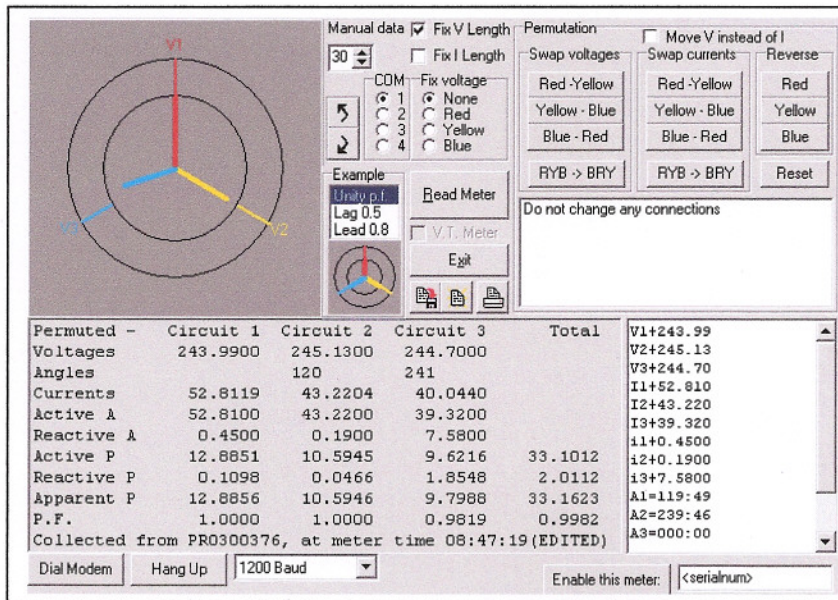
Once the connections were re-made the equipment was switched on so that we could confirm correct operation of the meter as confirmed by the screen shot below.

Our conclusion is that the meter was incorrectly wired from day 1 and as a result tenant 2 would have been over billed for a number of years.

A visit was organised for Saturday the 22nd of August so that the supply to the meter could be fully isolated and the wiring checked. The contractor had used the same colour cable for all current transformers (CT) and so six (two from each CT) identical cables had been threaded through a length of conduit with no means to identify which cable belonged to which CT or which cable was the S1 and which was the S2 (The S1 goes to the meter and the S2 is the return leg from the meter. This forms a circuit and mixing these up will lead to a reverse current flow).

As this was the likely cause of the problem it was decided to disconnect all the cables at both ends and then re-connect using a multi meter continuity check to confirm correct connection.
